Vulcan Anti-Scale Reference Studies

Installation Details

Model	Vulcan S25
Location	Ibis Budget - Makassar Airport Sultan Hasanuddin Int'l Airport Maros, Sulawesi Selatan 90552 Indonesia
Install Area	Guest Rooms - Bathroom Water Heating Elements

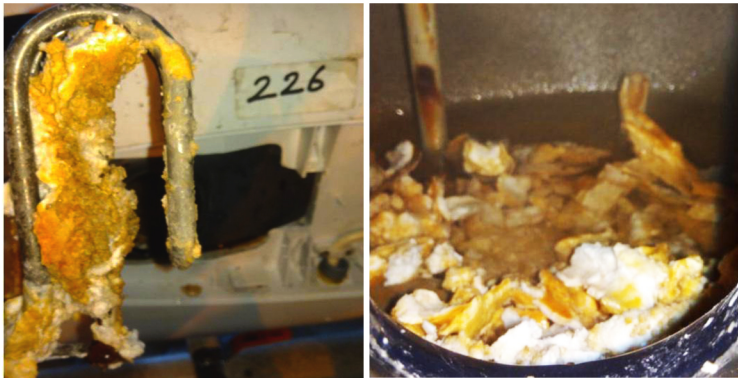
Several rooms were monitored before Vulcan was installed and had large amounts of scale chunks on the heating element and at the reservoir sump (see pictures 2 & 3). Vulcan was installed at the main incoming water line to eliminate this problem (see picture 4)

Pictures 2 & 3. Scale previously coating the heating element and reservoir sump. (Picture taken from one of the rooms at IBMA hotel)

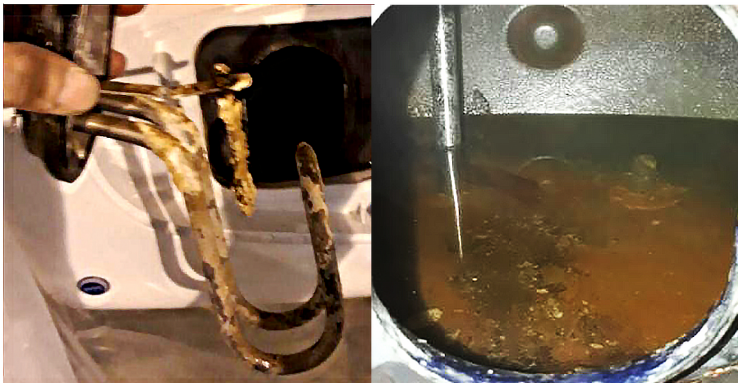
Scale gradually disappeared from the elements and reservoir sump. After 3 months scale is entirely gone from water heater elements and the reservoir sump.

Pictures 5 & 6. 3 weeks after Vulcan installation, initial scale has been eliminated.

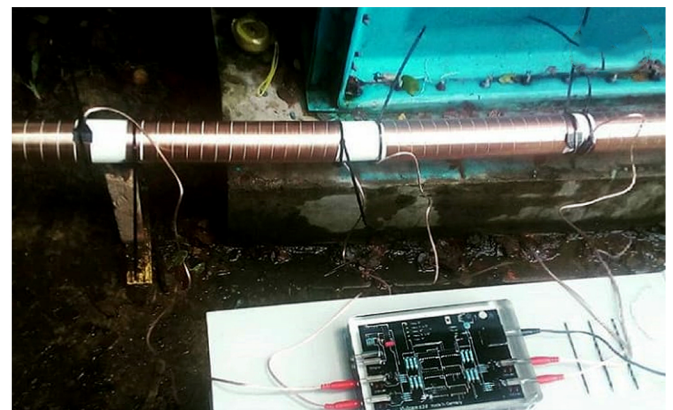
Picture 4. Vulcan installation process at the main incoming water line.

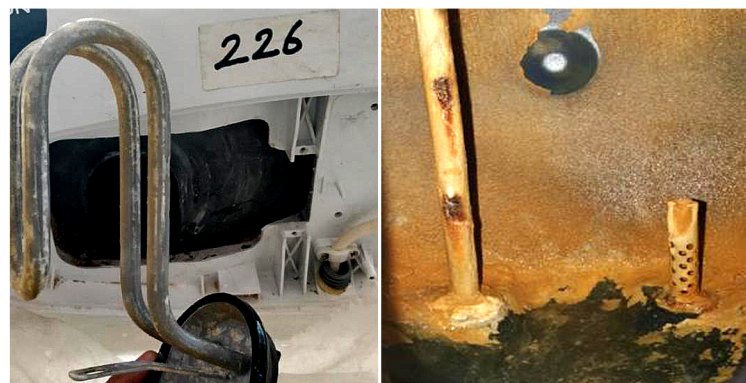
Pictures 7 & 8. 12 weeks after Vulcan installation, no scale at all.

Vulcan has shown to successfully reduce time, energy and capital required by the hotel for water system maintenance. All pictures were taken from one out of ten rooms that were monitored before and after Vulcan was installed, and all rooms' water heater elements were also found to be free of scale.
