## Installation Details

**Location:** A car engine manufacturing factory, Hyundai Motor Ulsan

**Area:** A cold water circulation pipeline for the cooling tower and the induction hardening machine

Vulcan S25

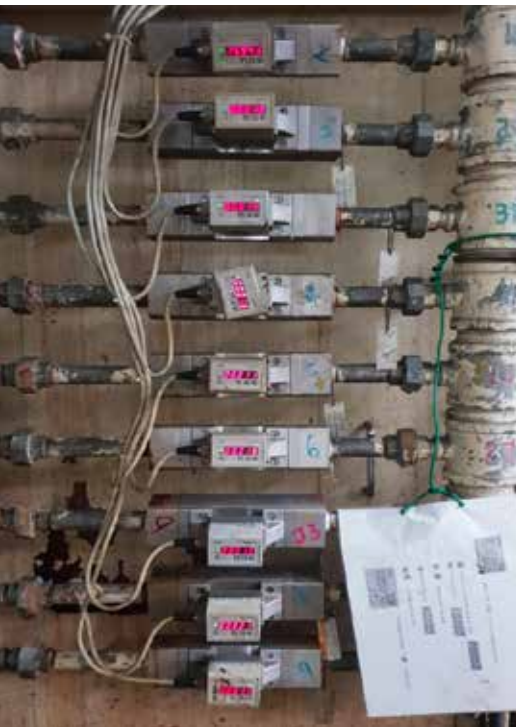
There are 9 secondary small pipes with water meters. These meters were installed to make sure a stable flow rate. If the flow rate goes down, it would cause a problem of the induction hardening machine. Therefore, the pipes had to be cleaned manually every 2-3 months.

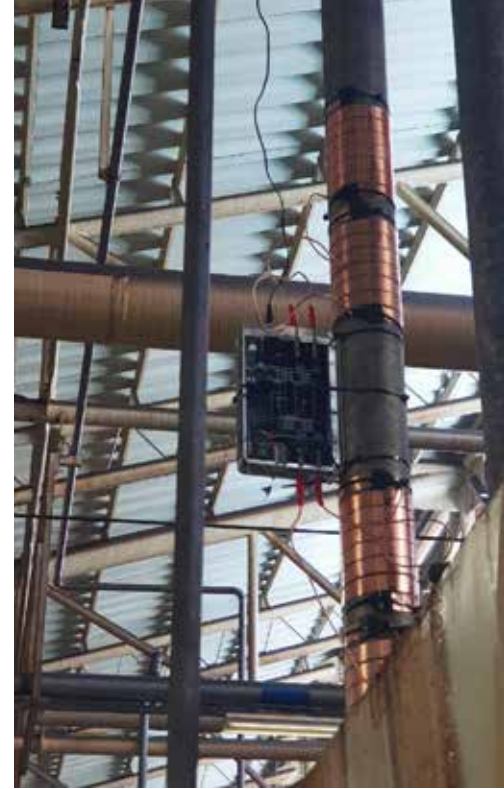
Vulcan S25 was installed around 50 meter before the induction hardening machine.

**Installation of a Vulcan S25 unit:** May 21st, 2018.

Note: scale was not manually removed before the Vulcan was fitted on source pipe (see photo).

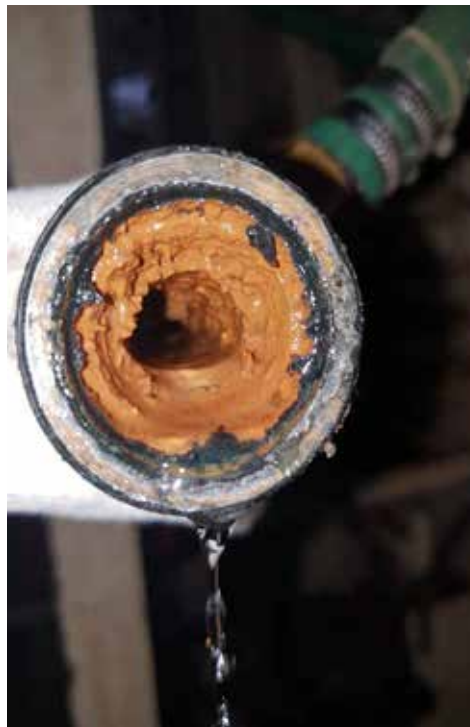
**First inspection:** May 21, 2018.

Inside of a secondary small pipe, before Vulcan S25 was installed.

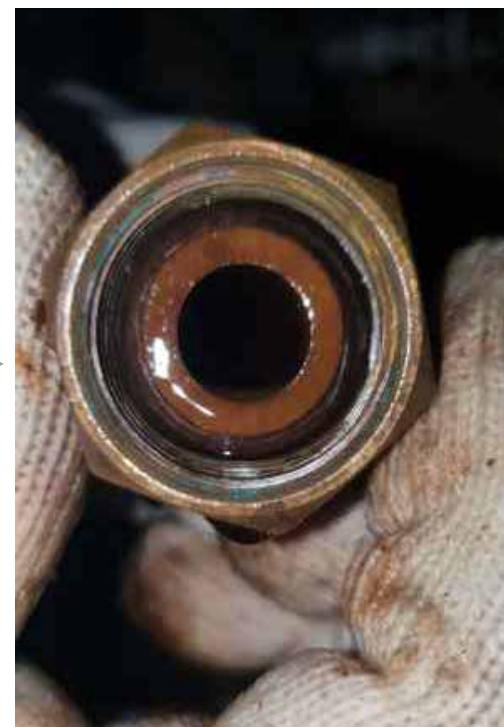
**Last inspection:** November 21, 2018.

2. After Vulcan S25 had been installed for 6 months, the secondary pipes were opened: scale that had been left in piping had disappeared and all 9 secondary pipes had become clean (see photo).

After 6 months with Vulcan treatment: the pipe is free of scale.
